SHAWNEE DAM

NDI I.D. NO: 832

**PHASE I INSPECTION REPORT
NATIONAL DAM INSPECTION PROGRAM**

SEPTEMBER 1978

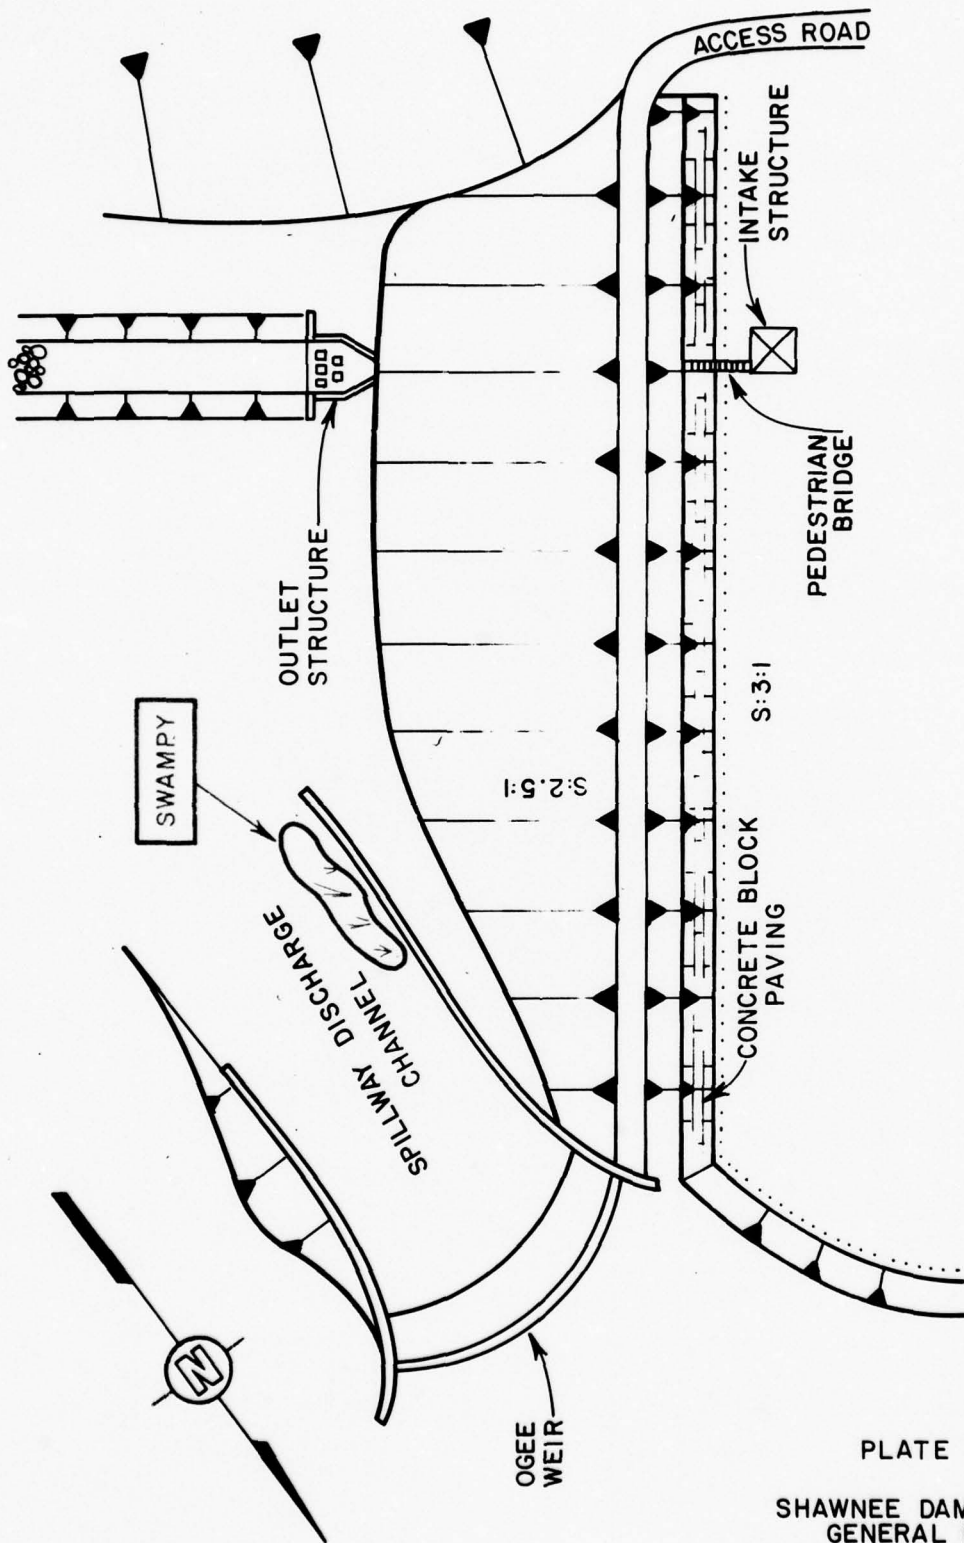
PLATE 7

The specific observations are illustrated in Plate 7 and in the photographs in Appendix C.

In general, the condition of the dam is considered to be good. Only one minor swampy area was observed in the emergency spillway discharge channel. No flow was observed and it appeared that the probable source was surface runoff.

No conditions were observed that would require attention at this time. A swampy area was found in the emergency spillway discharge channel which appeared to be surface runoff. This area should be periodically observed to document whether or not a seepage condition is developing.
